# Correlation between breakdown voltage and scratches?

Presentation by John Gerling

11-17-04

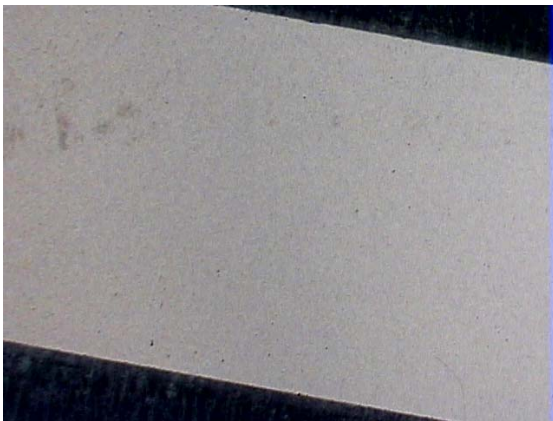
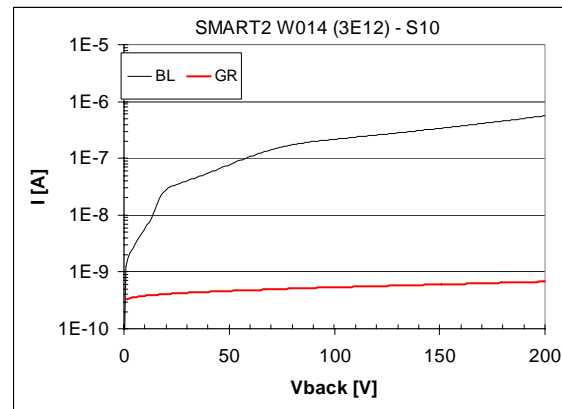
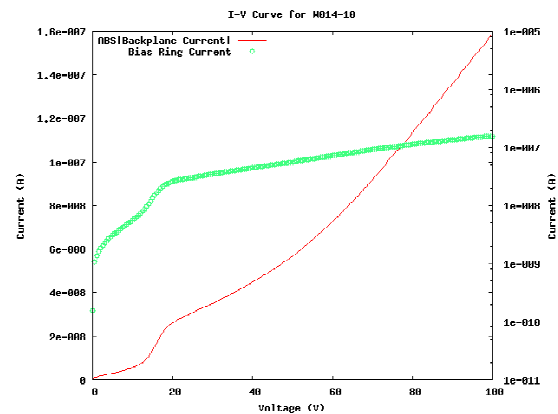
# SMART2 W014-10

No pictures available, topside un-damaged.

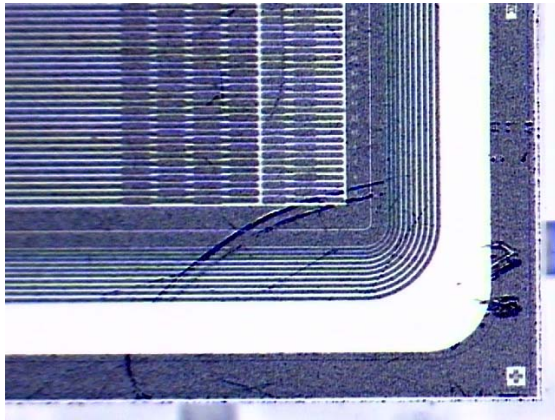
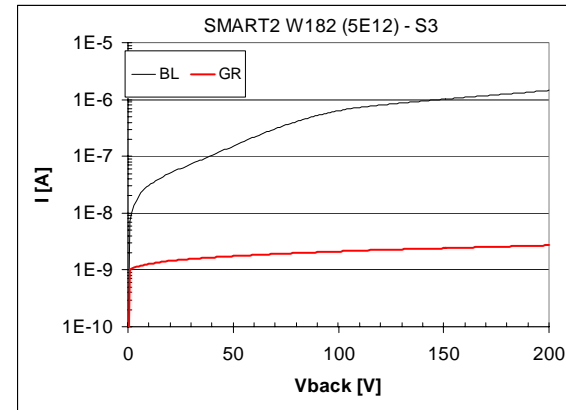
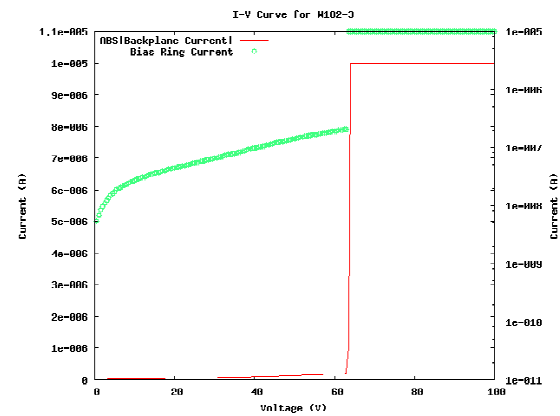
# SMART2 W182-3

Bonded detector, unable to document backside.

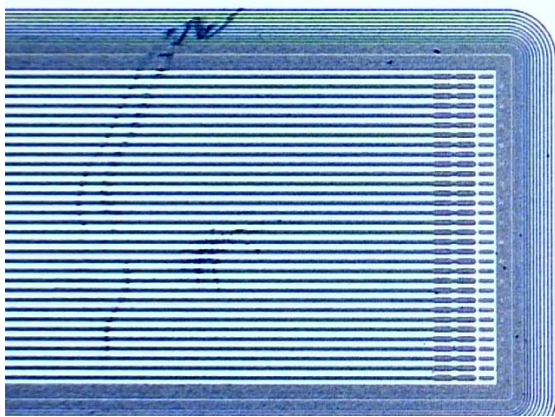
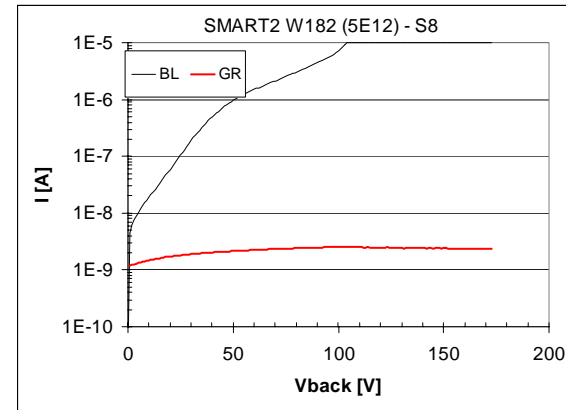
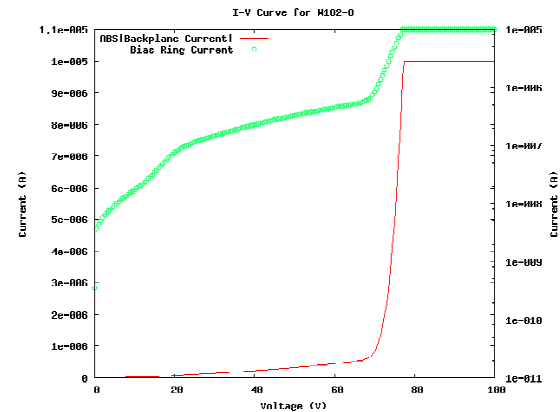
# SMART2 W182-8

No backside photo available,  
device currently under going  
tests.
