ATD Tracker Subsystem Development

Robert P. Johnson

Santa Cruz Institute for Particle Physics

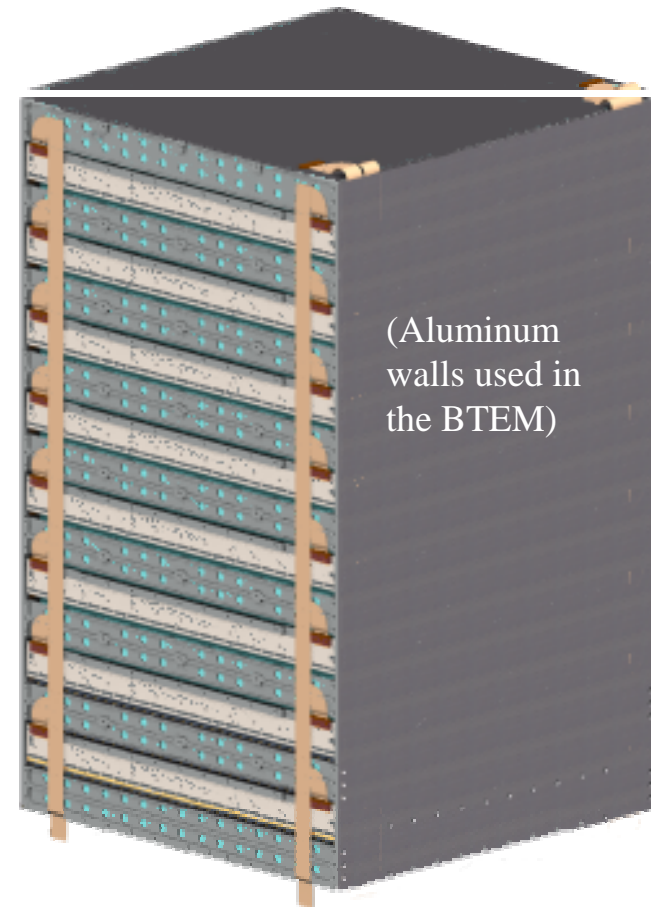
BTEM Tracker Module

- One tower with 32 cm × 32 cm of Si.
- 17 “tray” modules (aluminum closeouts).
- 16 x,y planes
 - 11 with 2.5% X_0 Pb on bottom
 - 3 with 25% X_0 Pb on bottom
 - 2 with no converter
- Every other tray rotated by 90°, so each Pb foil is followed immediately by an x,y plane (2 mm gap between x and y).
- Electronics on the sides of trays
 - Minimize gap between towers.
 - 8 readout modules on each of 4 sides.
- Trays stack and align at their corners.
- The bottom tray has a mounting flange.
- Aluminum walls provide stiffness and thermal pathway to the base.

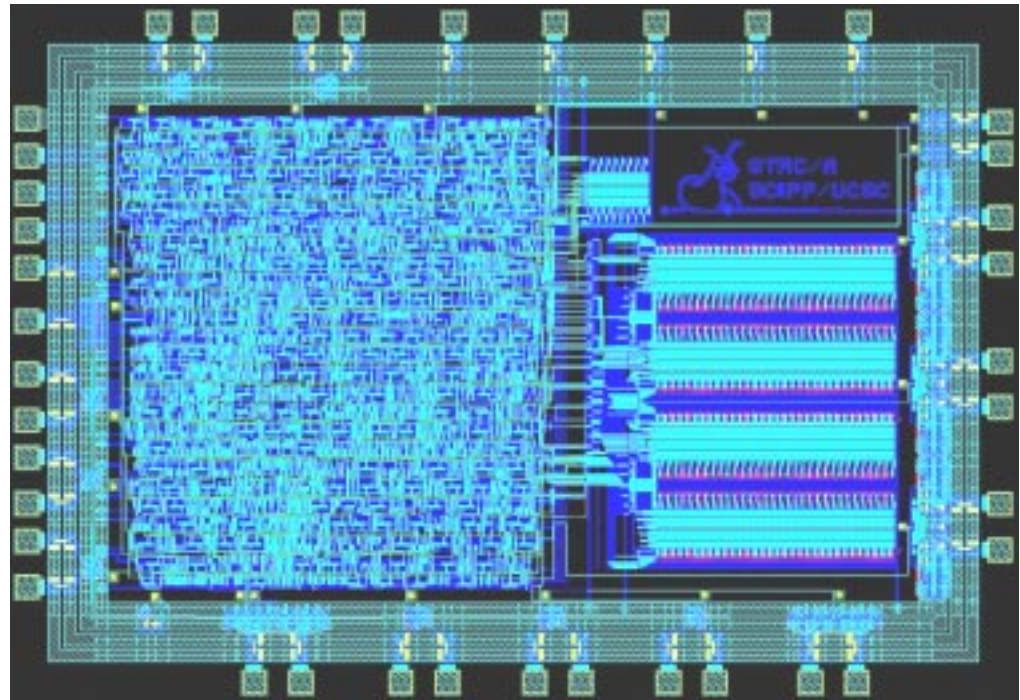
Cadence layout of the GLAST Tracker Readout Controller chip (GTRC). The left half is logic made from standard cells, while the right half is memory for buffering.

- Full custom CMOS IC, fabricated in the HP 0.8 μ m process for the beam-test tower.
- Logic design and layout uses DoD standard cells.
- Functions:
 - Zero suppression and formatting of the data.
 - Command and clock interface to the front-end chips.
 - Sequencing and buffering of the readout.
 - Time-over-threshold of the Fast-OR trigger output.
 - Communication via low-voltage differential signaling (LVDS).
- Functioned reliably in the 1999 beam test at SLAC.
- The flight version will be done in the HP 0.5 μ m process (TBR).

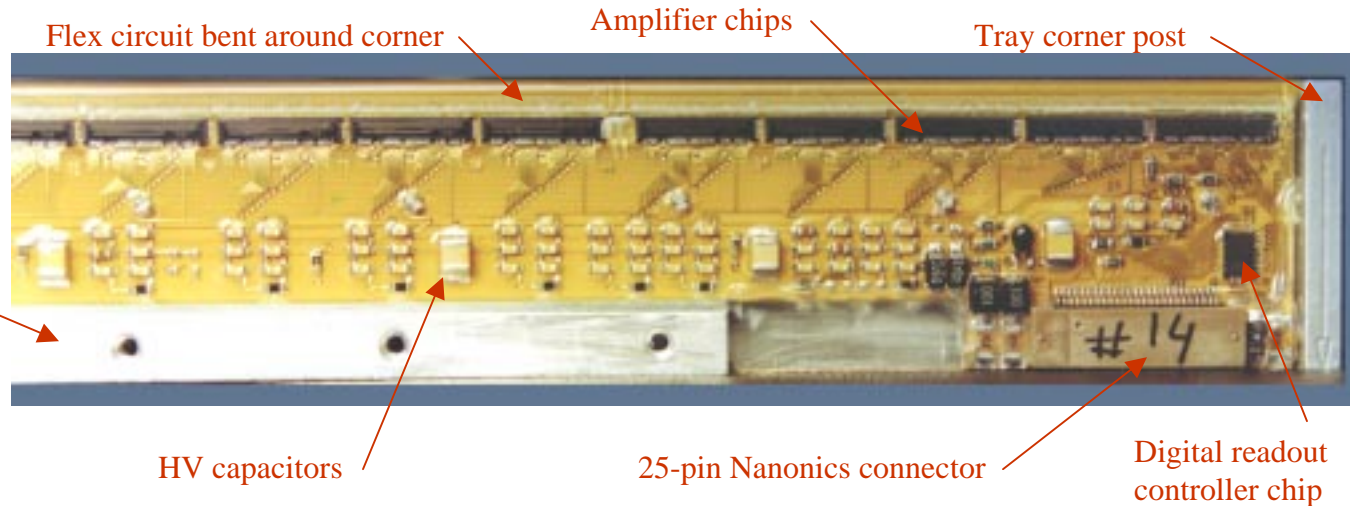
Hybrid PC Board

Hybrid mounted on a completed tray of the beam-test module.

Boss for mechanical and thermal attachment to the wall.

- 25 64-channel amplifier chips and 2 digital readout chips on each board (1600 ch.)
- 8-layer standard FR4 PC board with minimum 4-mil traces and spaces.
- Gold body for wire bonding. Conformal coated after assembly.
- Lots of filtering and decoupling for bias, power supplies, etc.
- Careful attention to shielding between analog and digital and to maintaining clean current returns for the detector signals.
- Temperature monitoring built in.
- ***Excellent performance in the 1999 beam test. No evidence of noise isolation or grounding problems.***

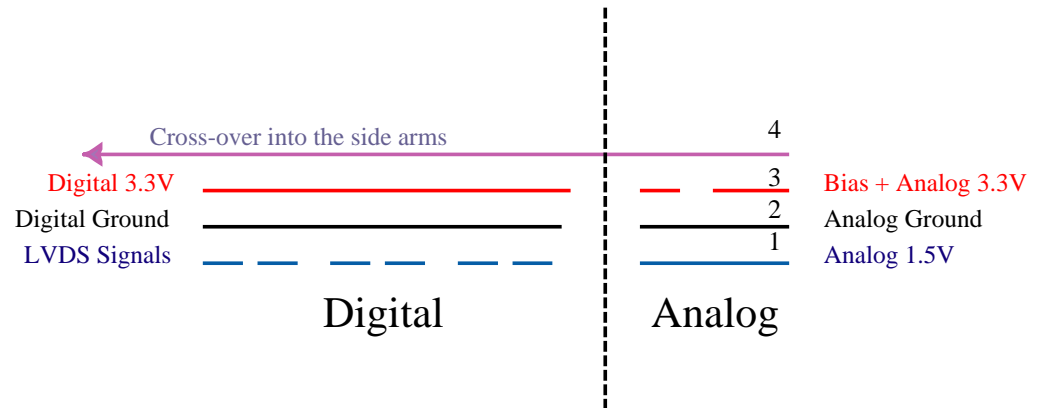
4-layer cable cross section, showing a schematic representation of the arrangement of conductors.

- Custom 4-layer flex circuits
- Standard processes, with Kapton and 1/2 oz copper.
- Connectors and other components are surface-mount soldered.

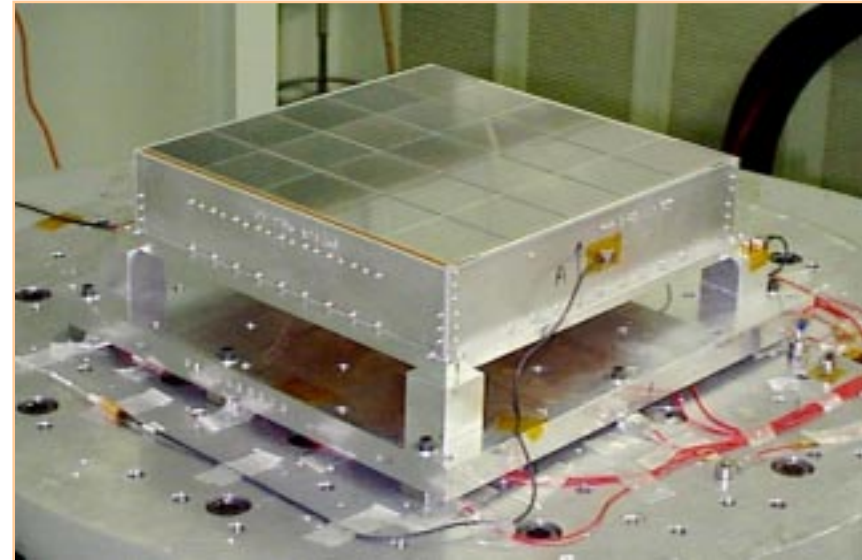
Vibration test setup at GSFC, for a tray with a full compliment of live detectors on top. The detectors are wire bonded to readout electronics.

- Two trays, one with live detectors and electronics, were vibration tested at GSFC.
- Random-vibration testing to full GEVS qualification levels did not produce any detectable damage (including no broken wire bonds) and did not affect detector leakage current.
- The first resonance was well above 500 Hz, demonstrating sufficient stiffness to avoid tray-tray collisions during launch.
- The data are presently being used to verify models in use for the development of a carbon-fiber tray design.

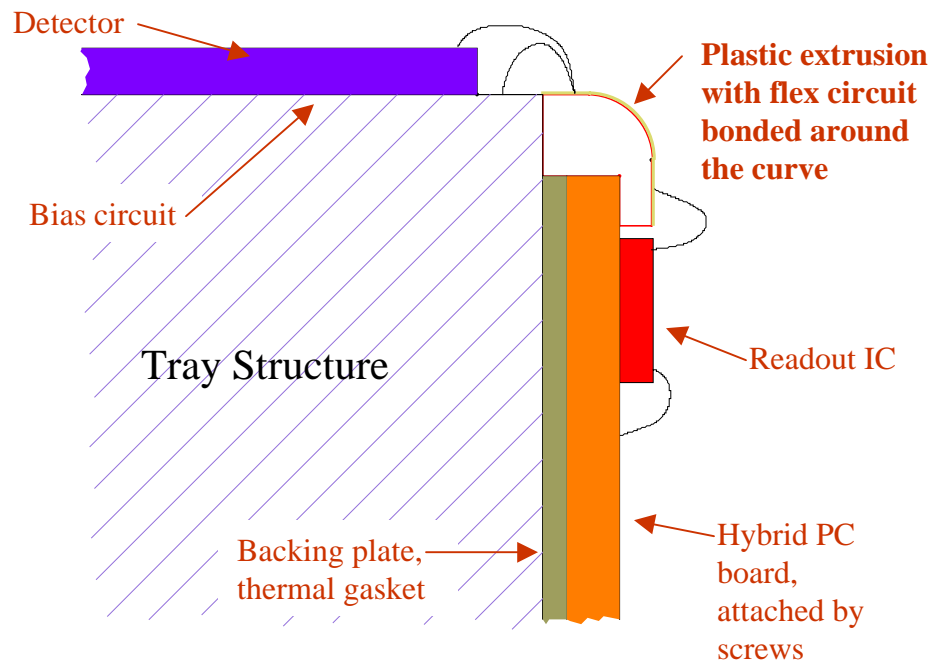
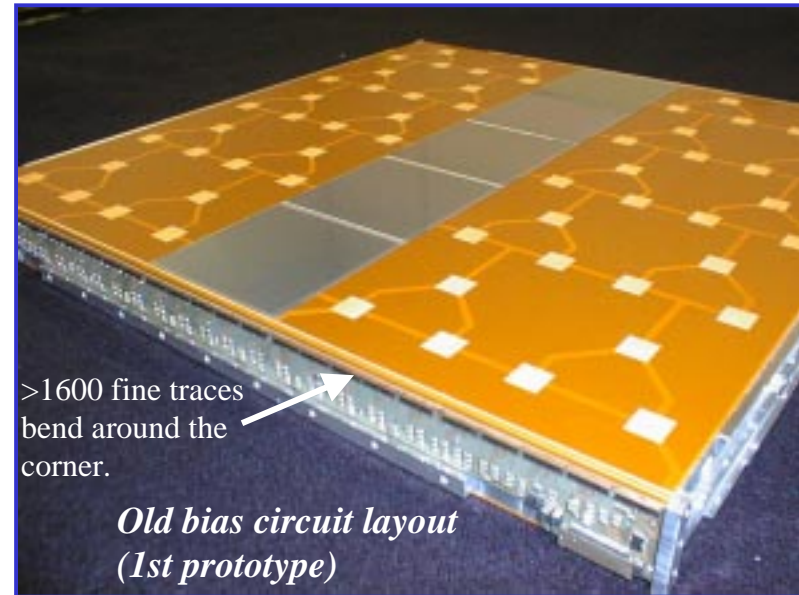
New concept under development (illustrated at left):

- The flex circuit for wrapping around the corner is separate from the bias circuit and is part of the hybrid assembly.
- It has 1 trace for each detector strip, plus bias and ground connections for each ladder.

- Top layer: pads for conductive adhesive, to carry the bias current to the detectors.
- Bottom layer: hatched ground plane, to isolate the detector bias from tray structure.
- Tongue with >1600 narrow traces carry signals and bias around the tray corner.
- **Difficult to mount and align electronics.**

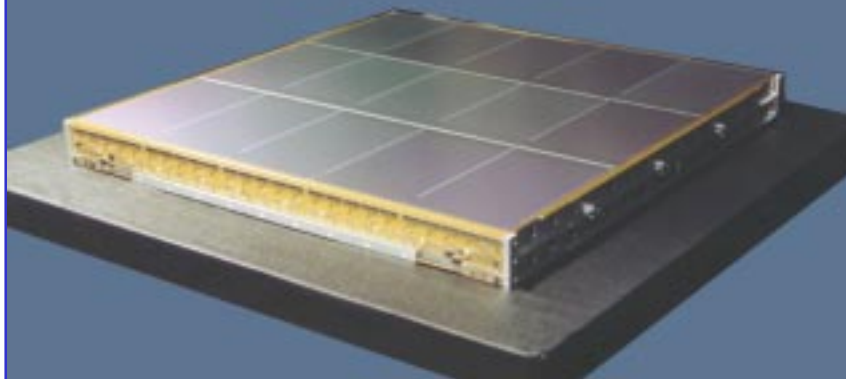
Single completed tray, detectors top & bottom

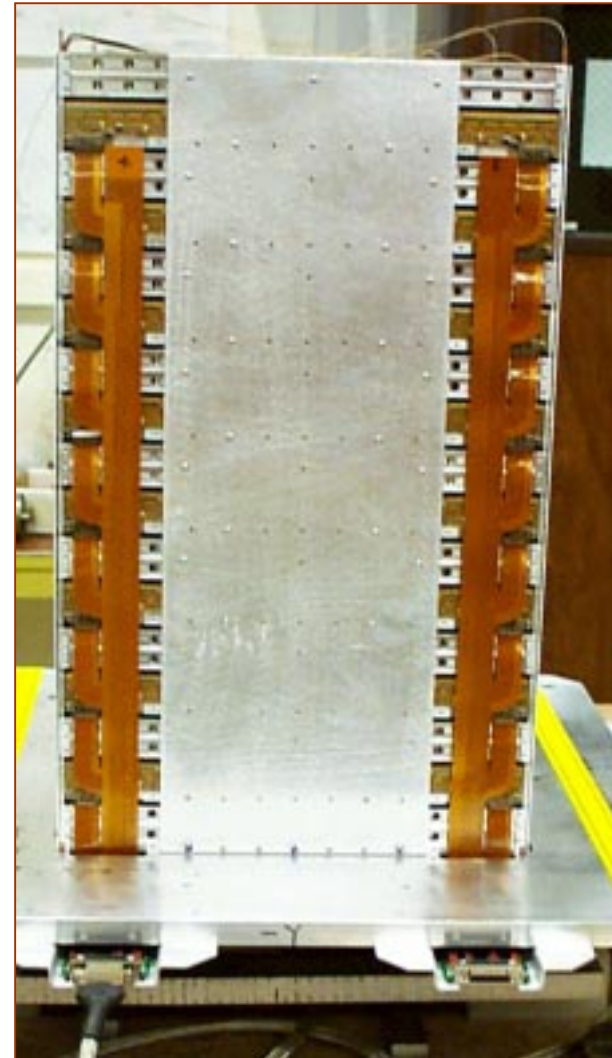
The completed beam-test tracker, with 2 side panels removed.

- 17 trays, 16 x,y planes
- 51,200 amplifier-discriminator channels, with 41,600 connected to detector strips.
- 130 32-cm detector ladders (out of 160 needed for the complete device), for 2.6 m² of silicon.
- 11 x,y planes with 3.5% Pb foils
- 3 x,y planes with 25% Pb foils

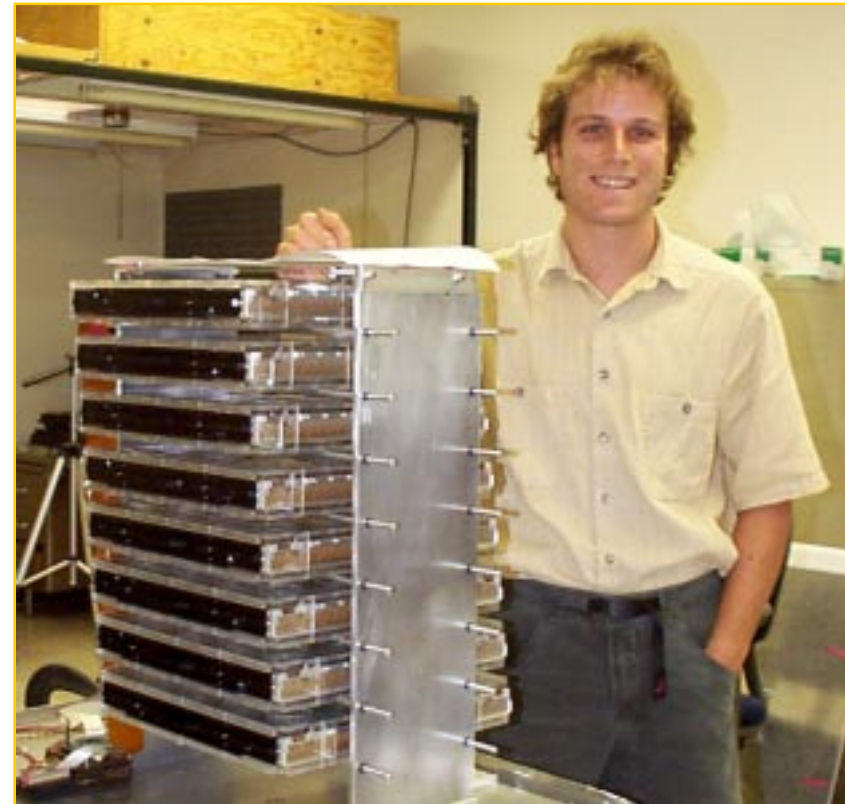
Setup used to test 8 trays at a time with cosmic-rays and the actual DAQ. The trays are still in protective plastic enclosures and have aluminum handles attached to the sides.

- Detectors tested by manufacturer (IV and coupling cap) and visually scanned by us.
- IV curves taken again after edge bonding, wire bonding, and before mounting on the tray.
- Capacitance measured on an automatic probe station for each strip after wire bonding to detect broken caps, broken metal, missing wire bonds, and shorts. *Only 18 bad strips found and isolated by removing wire bonds.*
- ICs thoroughly tested on the wafer by an automatic probe station.
- Hybrids tested and burned in before mounting on trays.
- *The result is only a handful of dead or noisy channels, plus one noisy ladder (as yet unknown reason).*

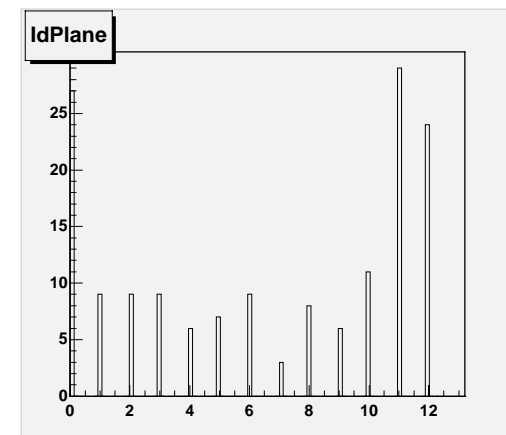
Distribution of photon-conversions per tracker plane.

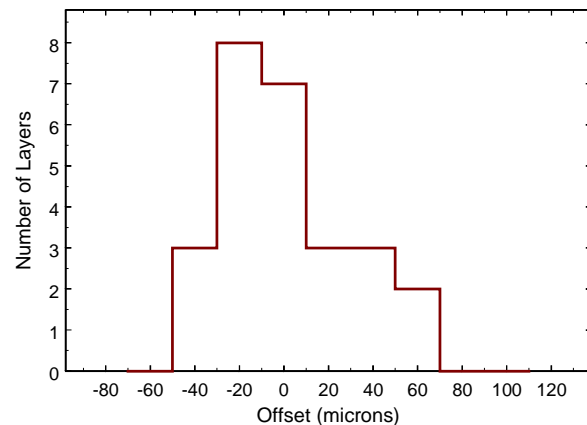
Offsets from 26 of the 32 layers, as obtained from 20-GeV positrons.

- Tray-to-tray alignment has been looked at in cosmic-ray and positron data and appears to be within our goal of 50 micron rms.
- More analysis is in progress with a position scan of hadron data, to get uniform coverage and enough sensitivity to study rotations.

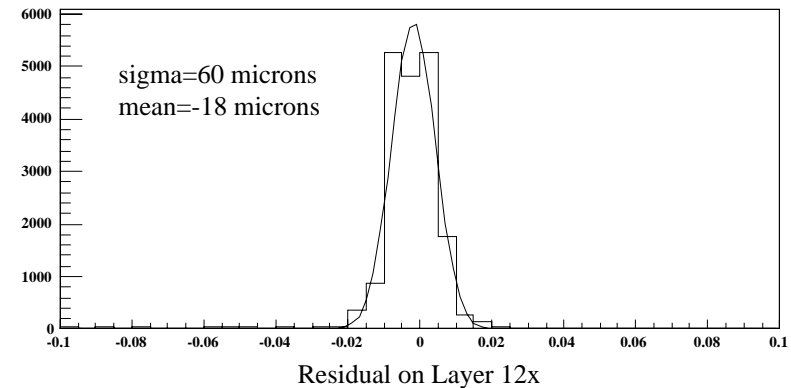
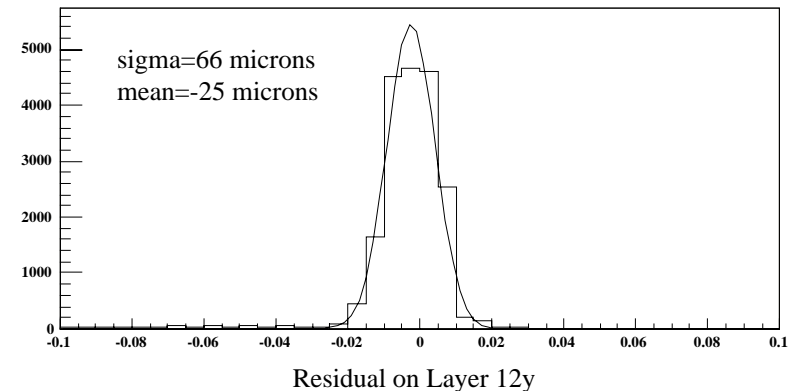
Residual distributions on Layer 12, from fitting 20-GeV positron tracks to straight lines in layers above and below. The width is as expected for 194 μ m pitch.

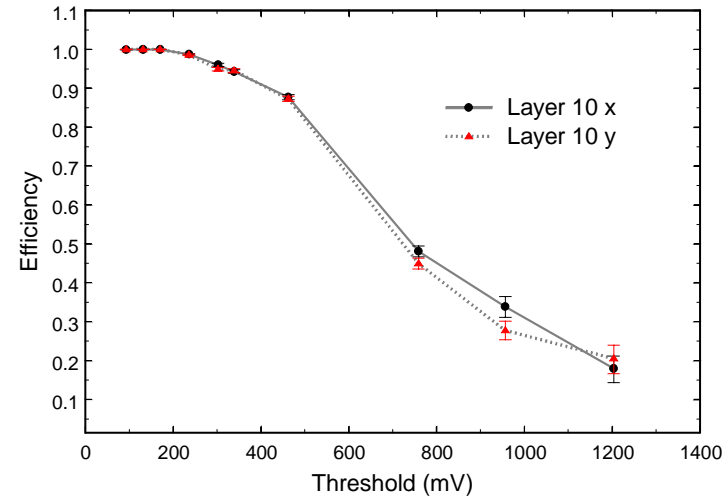
Hit efficiency versus threshold for 5 GeV positrons.

- Noise occupancy was obtained by inducing triggers, followed by readout, at random times.
- Hit efficiency was measured using single electron tracks and cosmic muons.
- *The requirements were met: 99% efficiency with $\ll 10^{-4}$ noise occupancy.*
- However, this was with no live trigger during the readout. We are now measuring occupancy during digital activity.

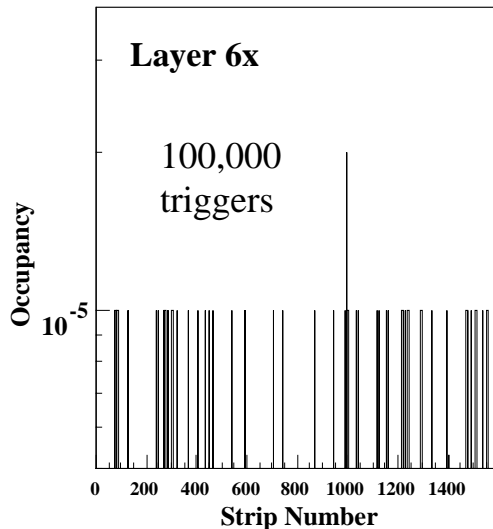
Noise occupancy and hit efficiency for Layer 6x, using in both cases a threshold of 170 mV. No channels were masked.

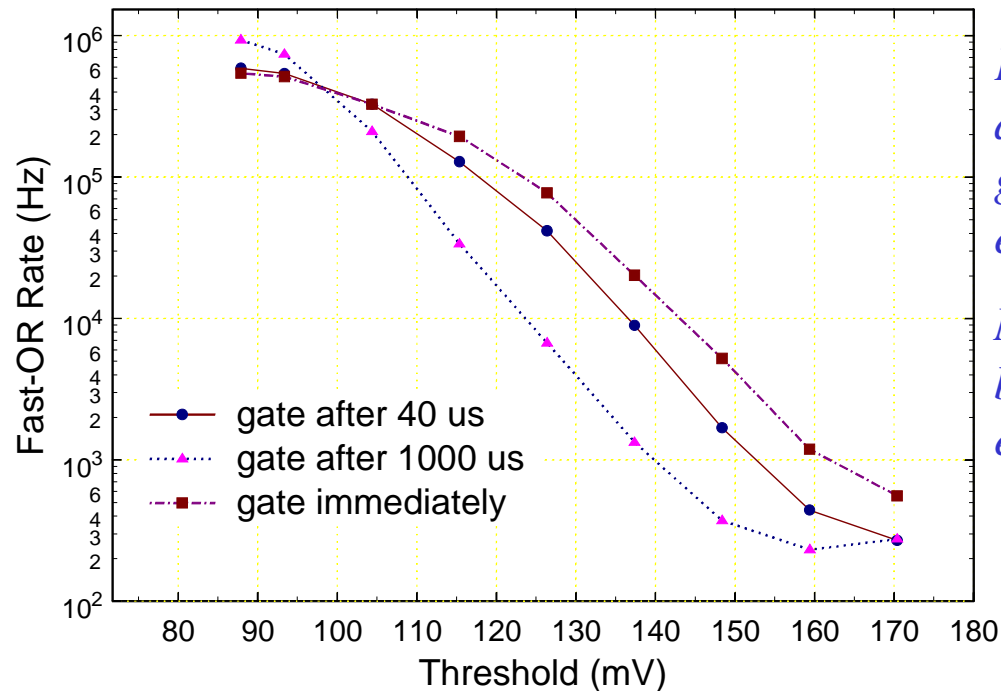
Fast-OR rate in layer 0 accumulated in a 500 μ s gate following a previous external trigger.

Note that the readout begins 30 μ s after the external trigger occurs.

The beam test did not demonstrate adequately the trigger noise performance even in the self-triggering run, because of the large dead time imposed by the calorimeter. In nearly every case the tracker readout was finished before the trigger became live again. Therefore, we made the measurements above in the lab, in which we monitored the Fast-OR rate from a layer during the time that a readout is occurring. At the operating threshold (170 mV), the only significant additional noise occurs immediately after the readout clock turns on. *After that transient has passed, we see no problem from the digital activity.*
